## Improved design of large wind turbine blade of fibre composites based on studies of scale effects (Phase 1). Summary report

*Publication date:*  
2004

# Improved design of large wind turbine blade of fibre composites based on studies of scale effects (Phase 1) - Summary Report

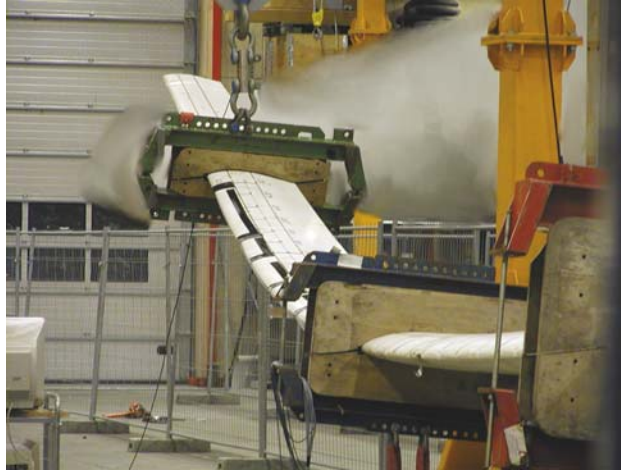
The global deflection of the blade was found not to be very sensitive to the damage that happens in the blade. It is therefore very difficult to give any criteria based on the global deflection about how close the blade is to failure. Fig. 2.5 shows the deflection of the blade (Test section 1) before failure and Fig. 2.6 shows the failure zone in the blade just after fracture.

*Fig. 2.5 Test of section 1; the blade deflects significantly before failure occurs.*

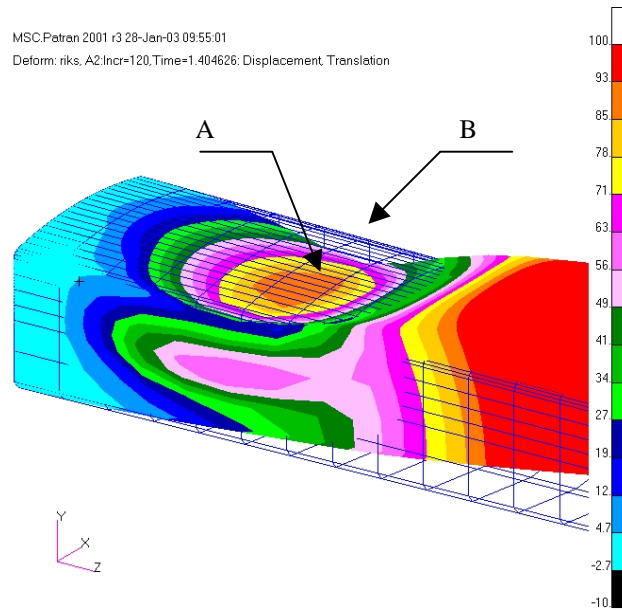
The deformation plot shows a relatively large local downward deformation of the compression flange, in point A on Fig. 4.4.

*Fig. 4.4. Displacement plot of post buckled section (displacement in the y-direction). The color range is in mm.*

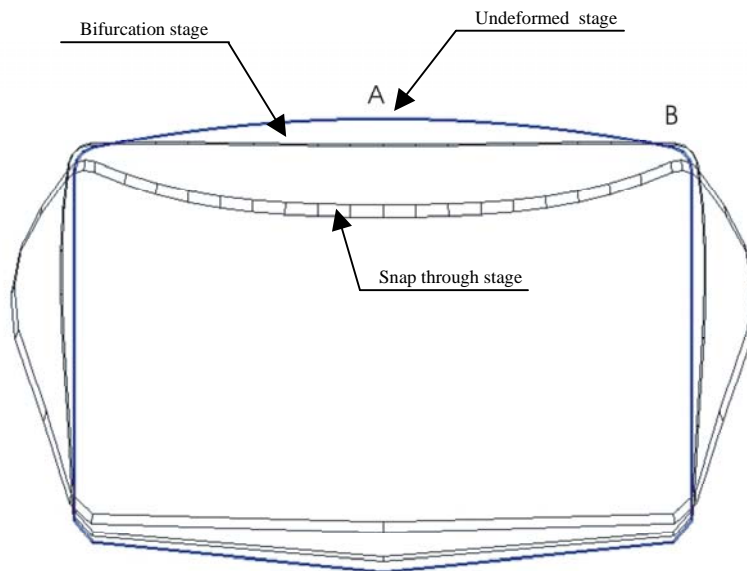
When the load reaches a certain level, the deflection of the flange, will “snap through”. See the three deformations stages in Fig. 4.5.

*Fig. 4.5. Transverse section of the main spar. Three deformations stages are shown.*

Following snap-through, the compression flange will find a new stable equilibrium. See deformation stage 3 in Fig. 4.5, where it can still carry some compression load but on a lower level than before the “snap-through” point was reached. The reduction in load carrying capacity will effect in collapse of the main spar if the surrounded structure does not have the capacity to carry this extra load. In all cases there is an eminent risk that there will be a permanent damage after such a “snap-through” limit has past.

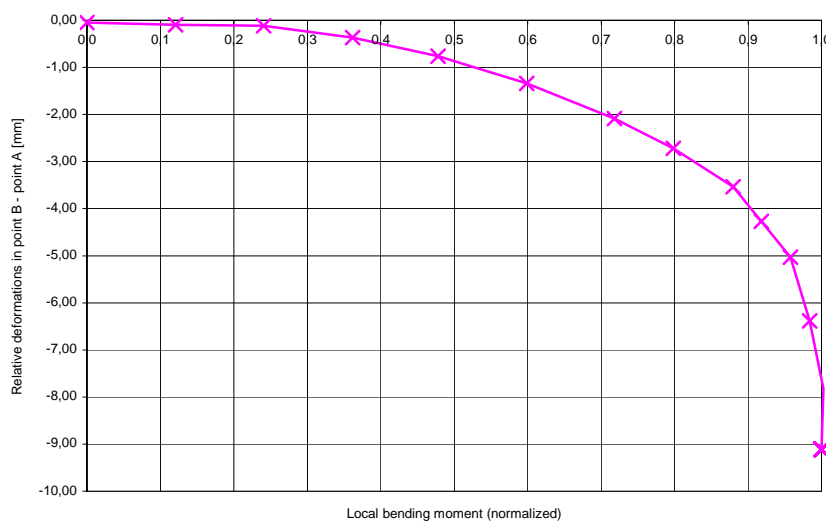
When we compare full-scale measurements Fig. 4.7 and FEM-simulations Fig. 4.6, the “relative deflections” in point A minus point B, show almost the same behaviour, which confirms that we actually have the bifurcation point just before the blade collapses.

*Fig. 4.7: Displacements versus load recorded at the full-scale test (test section 3)*
